**Appendix A: Photos of project area**

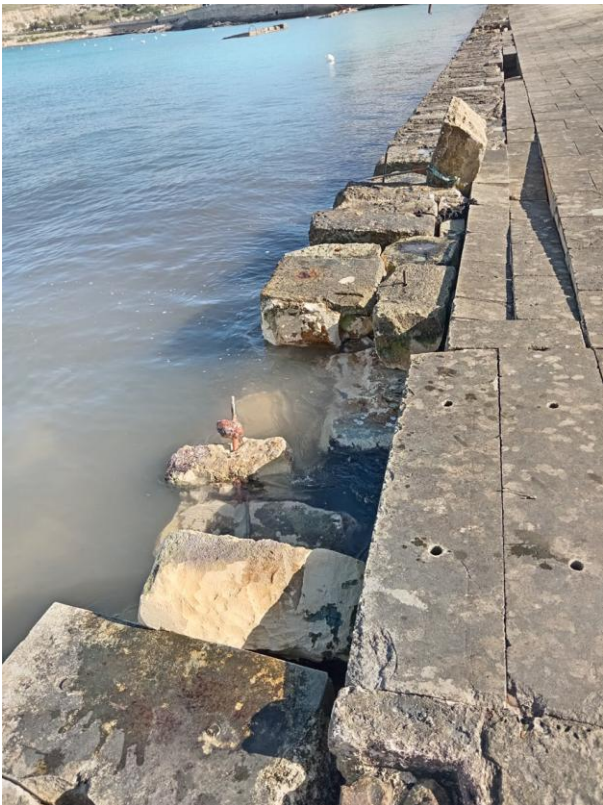
**Photo 1:** 24/02/2026 – *General damage across sea wall*

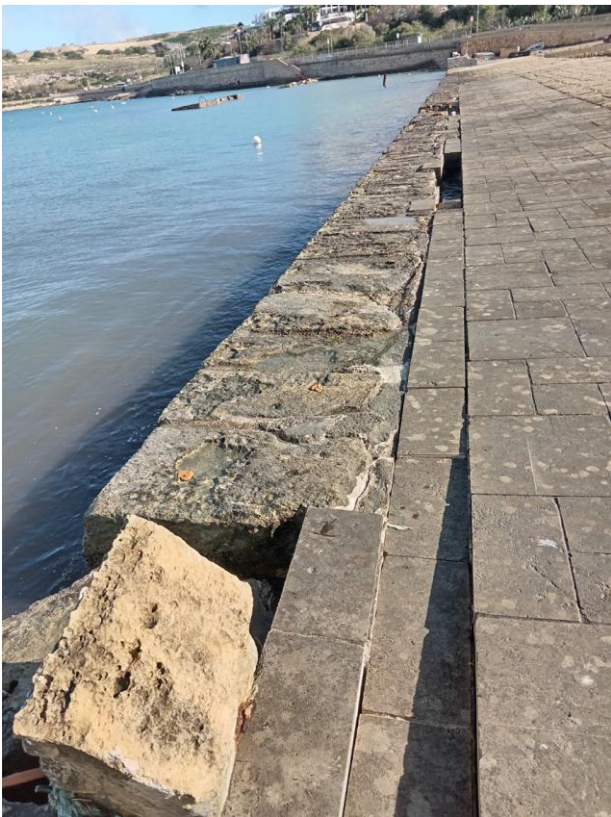
**Photo 2:** 24/02/2026 – *General damage across sea wall*

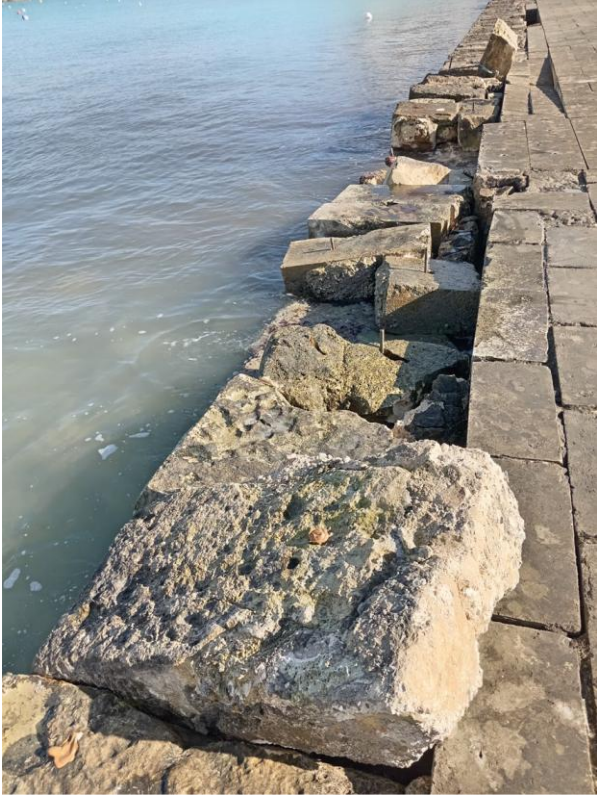
**Photo 3:** 24/02/2026 – *General damage across sea wall*

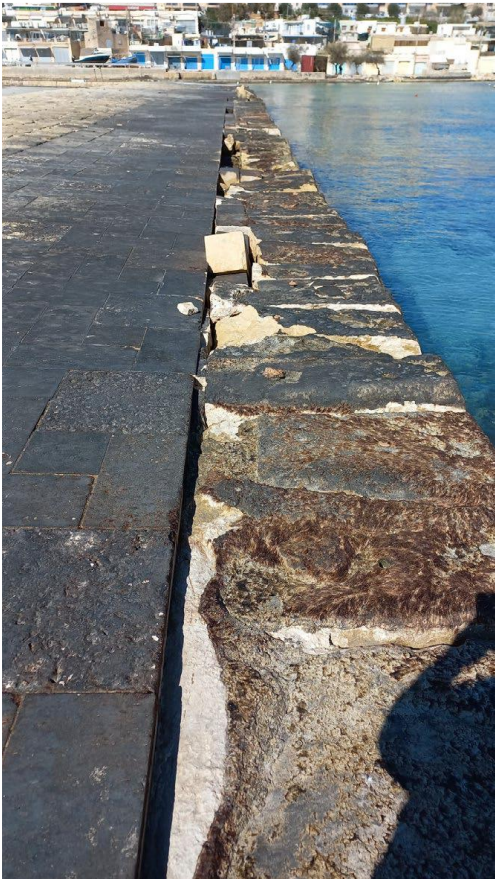
**Photo 4:** 24/02/2026 – *General damage across sea wall*

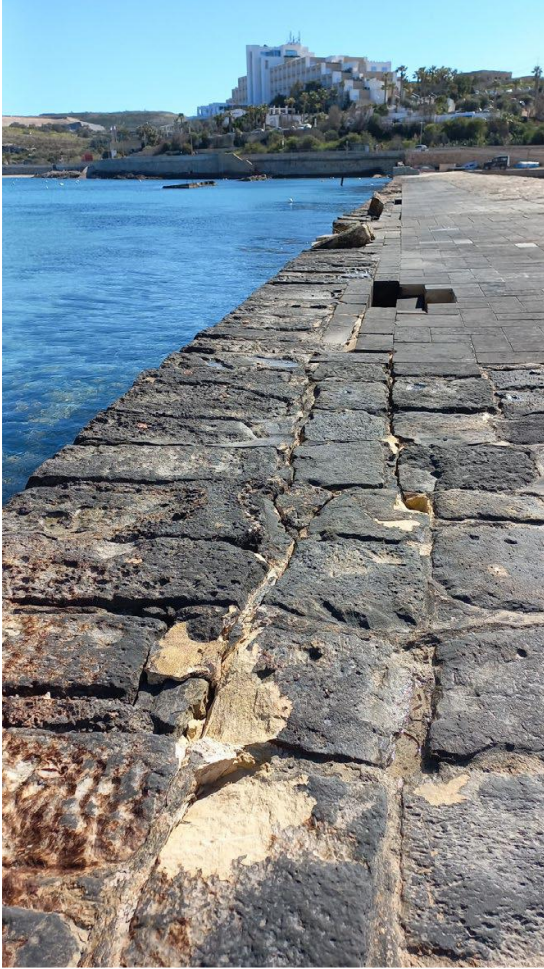
**Photo 5:** 24/02/2026 – *General damage across sea wall*

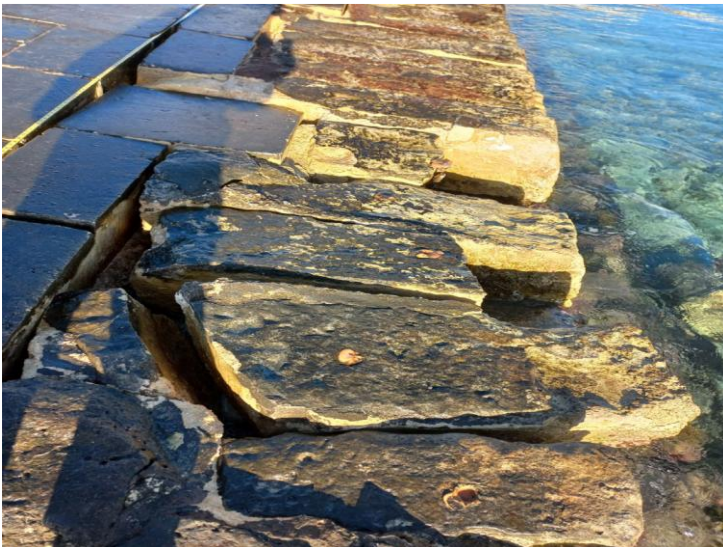
**Photo 6:** 24/02/2026 – *Displacement of the outer limestone masonry blocks*

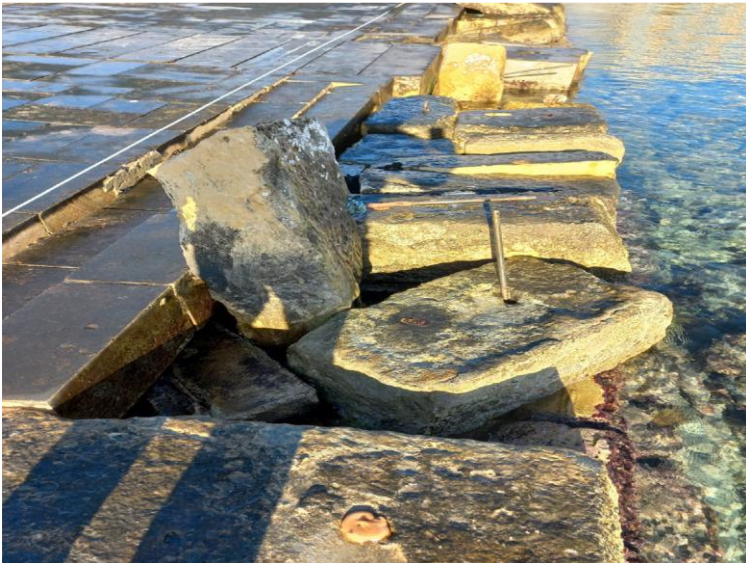
**Photo 7:** 24/02/2026 – Displacement of the outer limestone masonry blocks and the failed dowels

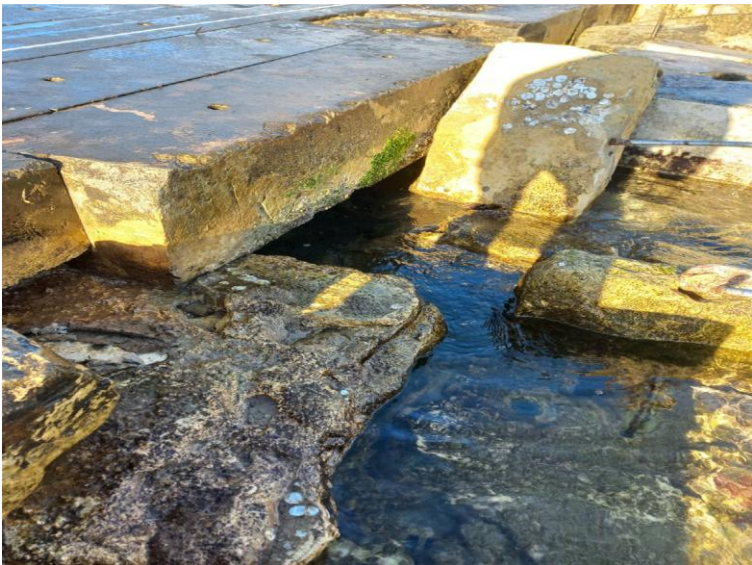
**Photo 8:** 24/02/2026 – Severely damaged lintels spanning over the canal

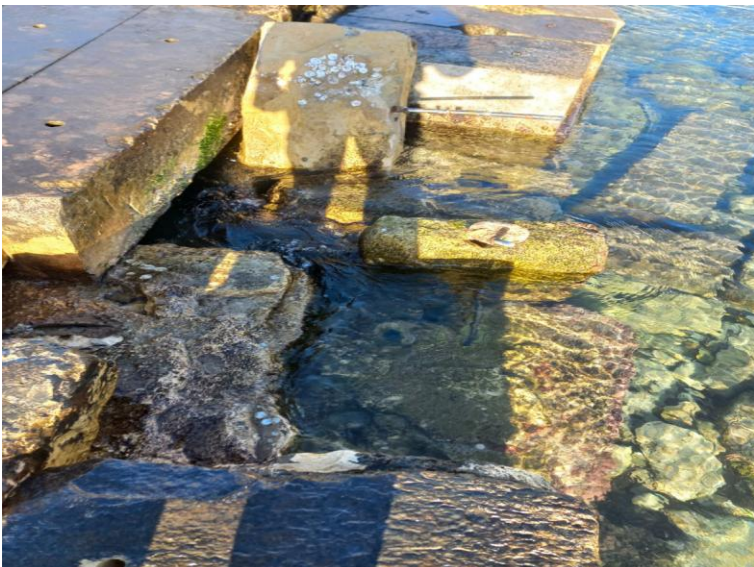
**Photo 9:** 24/02/2026 – Severely damaged lintels spanning over the canal

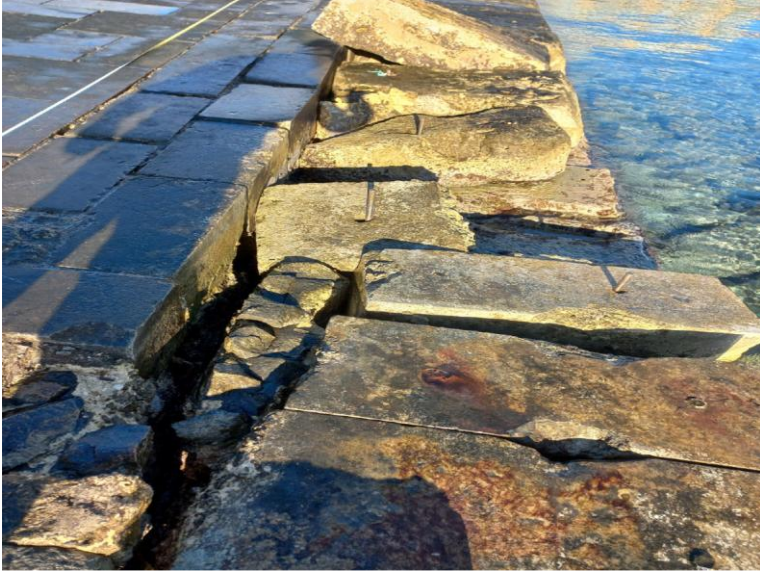
**Photo 10:** 24/02/2026 – *Displacement of the outer limestone masonry blocks and the failed dowels*

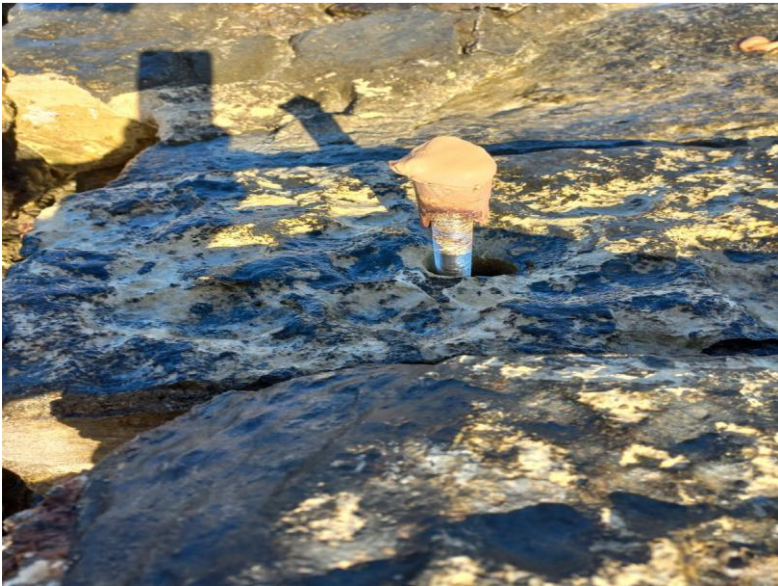
**Photo 11:** 24/02/2026 – *Bearing failure of the dowels*

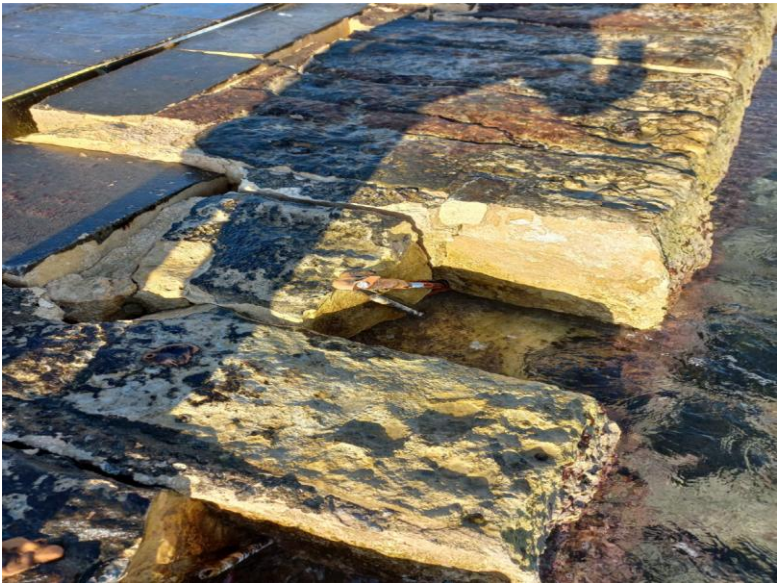
**Photo 12:** 24/02/2026 – *Bearing failure of the dowels*

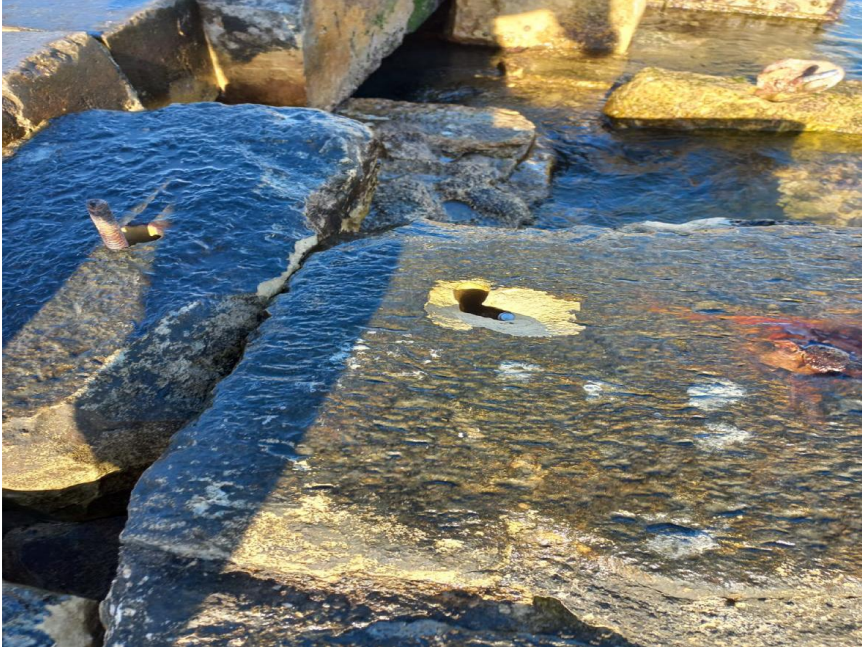
**Photo 13:** 24/02/2026 – *Bearing failure of the dowels and subsequent contact interface*

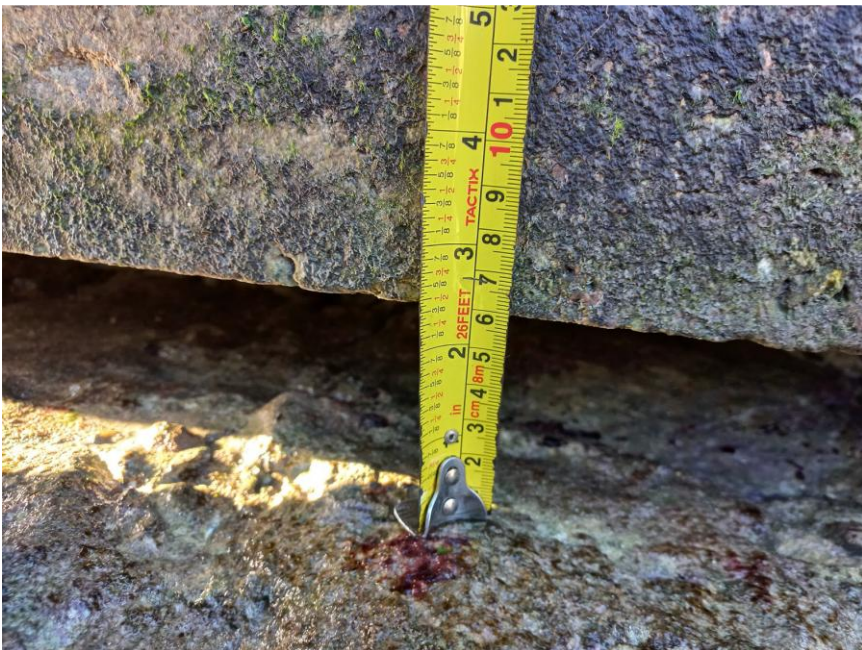
**Photo 14:** 24/02/2026 – *Underlying sand and/or fill material washed out resulting in the formation of voids*

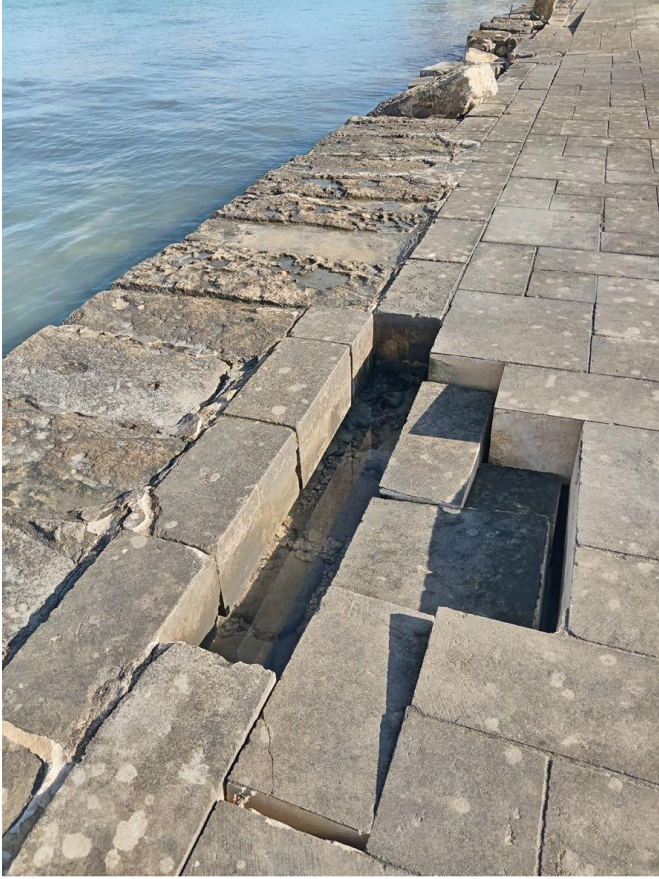
**Photo 15:** 24/02/2026 – *Settlement of the adjacent stone paving*
