BirdLife Malta objection to underground reservoir and to sanction existing pump room (PA/02643/26)

29/05/26

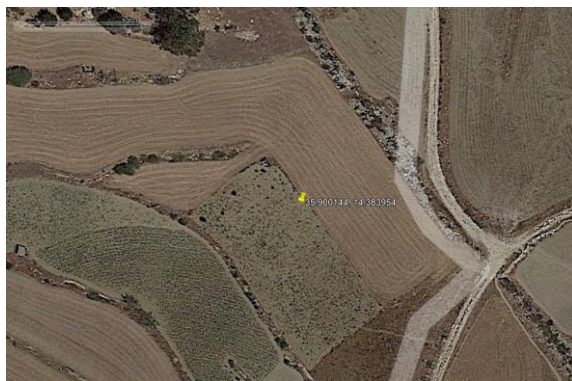
In April 2025, BirdLife Malta filed an illegality report with the Planning Authority concerning a water pond and structure built without permits on site (CM/387/25). Satellite imagery on Google Earth shows that the pond was not present prior to May 2024. In May 2021 there was no structure or pond on site, however, from April 2023 to June 2023, a structure appears which subsequently increases in size. The May 2024 satellite imagery shows the structure completed with a water pond.

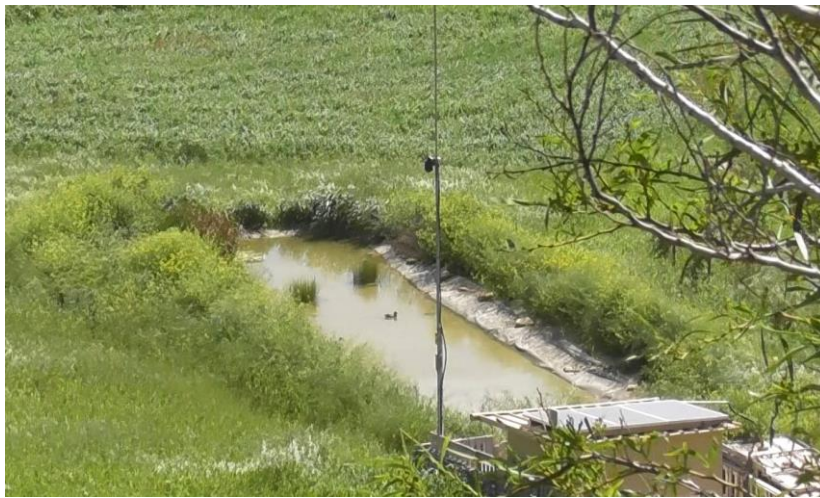
In 2025, BirdLife Malta took photographs of the artificial water pond. Such ponds have in the past been associated with hunting practices. The photograph below clearly illustrates that the site has been excavated to create and simulate a natural water body. Current satellite imagery seemingly shows that the water pond is no longer present or has since dried up. Nonetheless, the structure still stands, and the applicant is seeking the sanctioning of this structure as a 'pump room'. The legitimacy of its use as a pump room raises serious doubts, especially considering its association with the artificial pond and its apparent function as a bird hide.

Given that the 'pump room' has been built without permission and appears to have been constructed for the purpose of serving as a bird hide rather than for agricultural use, sanctioning this structure would constitute a direct breach of the above regulations.

In view of the above, BirdLife Malta strongly objects to this application and urges the Planning Authority to reject it. Approval in its current form and context would undermine the Authority's enforcement responsibilities and suggest tolerance of unauthorised development in rural areas. BirdLife Malta recommends that the applicant be required

to restore the site to its natural state and any development permission should not be issued until all illegalities are removed. Furthermore, any development on site should be subject to close monitoring both during and after construction to ensure full compliance.
